Town of Arlington, Massachusetts

PART A – Executive Summary Self- Evaluation and Transition Plan

November 2019

Part A – Executive Summary

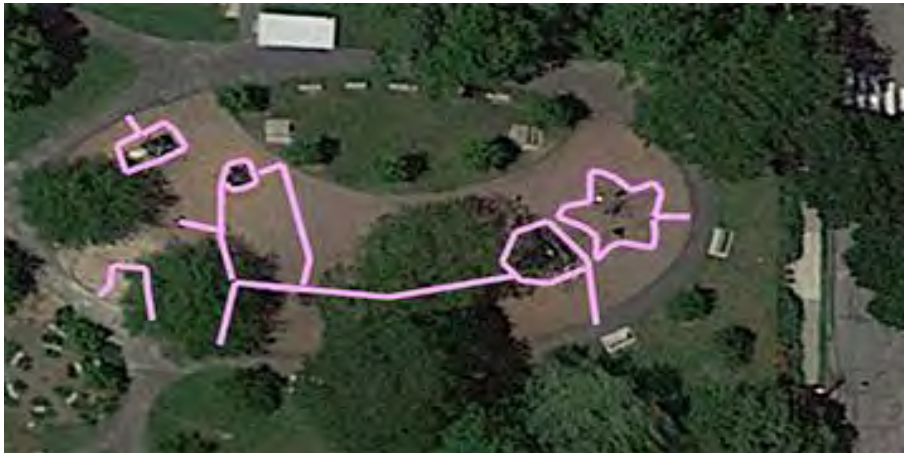
Magnolia Field Playground

The image below shows Magnolia Field playground. An accessible route is provided around the playground, however a 60-inch minimum accessible route to each play component in the playground is not provided. The pink lines show a proposed accessible route.

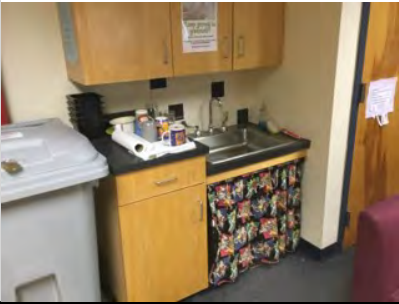
ID	Location	Floor	Room	Element	Type	Photo	Issues	Current Measure	Recommendations	Quantity	Price	Cost Estimation
Additional Access												
1	Main Office	1		Sink	N/A

Toe and knee clearances not provided Exposed plumbing underneath sink	- -	Remove cabinet and provide bracing to ensure there is a 25" knee clearance positioned for a forward approach. Insulate or otherwise configure pipes at sink.	1	889	\$889
Additional Access												
2	Nurse's Office	1		Sink	Lab

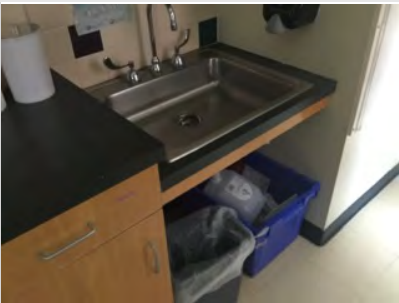
Toe and knee clearances not provided	-	Remove trash bins to ensure there is a 25" knee clearance positioned for a forward approach.	1	Labor	\$0
Approach and Entrance												
3	Stairwell 1 Exit	1		Emergency Exit	N/A

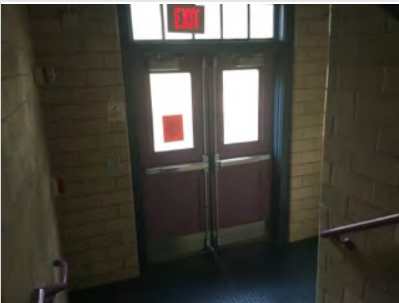
Emergency exit not on an accessible route Directional sign to accessible emergency exit not provided Tactile exit sign not provided	- -	Provide a directional sign indicating the location of the nearest emergency exit. Provide a tactile exit signs with raised characters and braille at exit doors. Mount signs between 48" - 60" above the finished floor on the latch side of the door.	2	116	\$232

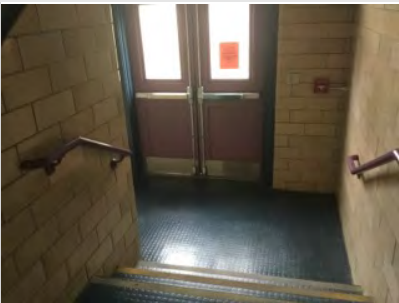
Approach and Entrance												
4	Stairwell 2 Exit	1		Emergency Exit	N/A

Emergency exit not on an accessible route Directional sign to accessible emergency exit not provided Tactile exit sign not provided	- -	Provide a directional sign indicating the location of the nearest emergency exit. Provide a tactile exit signs with raised characters and braille at exit doors. Mount signs between 48" - 60" above the finished floor on the latch side of the door.	2	116	\$232

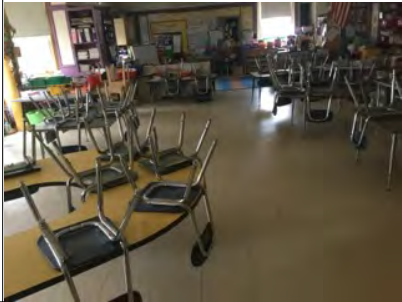
ID	Location	Floor	Room	Element	Type	Photo	Issues	Current Measure	Recommendations	Quantity	Price	Cost Estimation
Access to Goods and Services												
5	Classroom 105	1	105	Dining or Work Surfaces	Work Surface

At least one or 5% accessible tables not provided	21"	Ensure that at least one desk is accessible.	1	350	\$350
6	Classroom 105	1	105	Interior Access Route	N/A

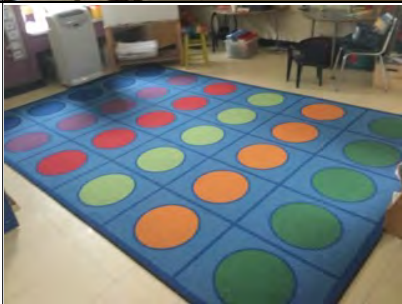
Surface not stable, firm, and slip-resistant	-	Secure the mat.	1	Labor	\$0
Additional Access												
7	Classroom 105	1	105	Sinks for Children's Use	Sink

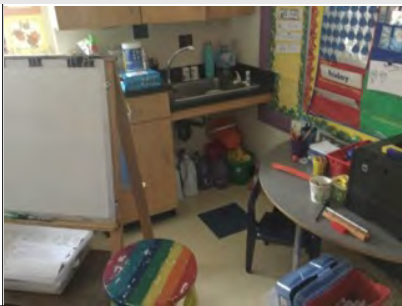
Knee or toe clearance not provided		Provide at least one sink with 25" knee and toe clearance positioned for a forward approach. Relocate stored items.	1	Labor	\$0
Access to Goods and Services												
8	Classroom 105 Toilet Room	1	105	Signage	Designation

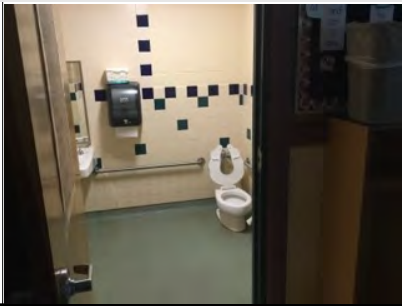
Not provided	-	Locate signage with raised characters and braille alongside the door on the latch side. After the toilet room is made accessible, provide a sign containing the International Symbol of Accessibility.	1	116	\$116

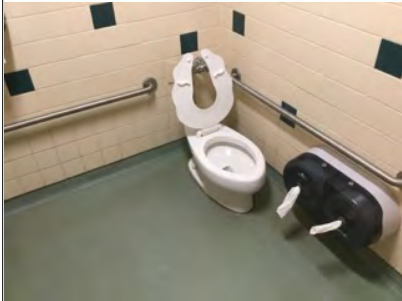
ID	Location	Floor	Room	Element	Type	Photo	Issues	Current Measure	Recommendations	Quantity	Price	Cost Estimation
Toilet Rooms for Children												
9	Classroom 105 Toilet Room	1	105	Single-User Toilet	N/A

Toilet seat < 12" or > 15" high (K - 3) Centerline < 12" or > 15" (K - 3) Side or rear grab bar < 20" or > 25" high (K - 3) Non-compliant toilet paper dispenser	11" 10" 19" -	Toilet room is designed for Pre-K students. To convert for students in Kindergarten: Install a toilet with a seat between 12"- 15" high. Relocate toilet so that the centerline is between 12" and 15" from the side wall. Locate grab bars between 20"- 25" above the floor. Replace toilet paper dispenser if it does not allow continuous paper flow.	1	3556	\$3556
Access to Goods and Services												
10	1st Grade Classroom	1	106	Dining or Work Surfaces	Work Surface

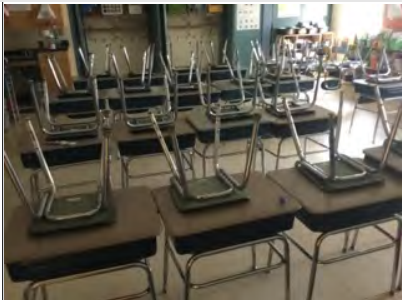
At least one or 5% accessible tables not provided	19" wide	Ensure that at least one desk is accessible.	1	350	\$350

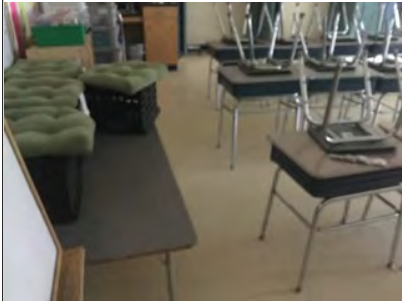
11	1st Grade Classroom	1	106	Interior Access Route	N/A

Route < 36" wide	20"	Ensure that a clear width of 36" min. is maintained at the accessible route. Relocate furniture.	1	Labor	\$0
12	1st Grade Classroom	1	106	Interior Access Route	N/A

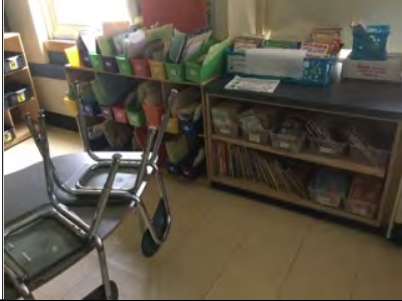
Route < 36" wide	18"	Ensure that a clear width of 36" min. is maintained at the accessible route. Relocate furniture.	1	Labor	\$0
13	1st Grade Classroom	1	106	Interior Access Route	N/A

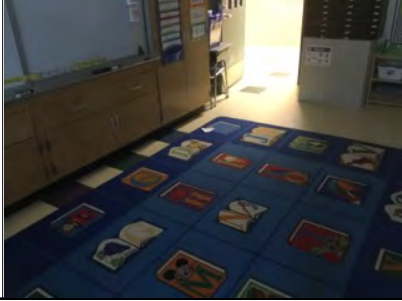
Surface not stable, firm, and slip-resistant		Secure the mat.	1	Labor	\$0

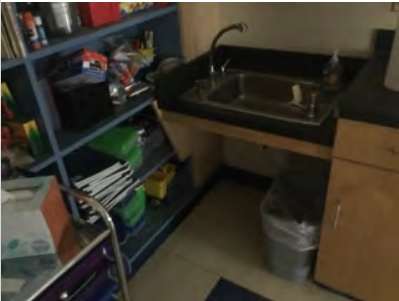
ID	Location	Floor	Room	Element	Type	Photo	Issues	Current Measure	Recommendations	Quantity	Price	Cost Estimation
Additional Access												
14	1st Grade Classroom	1	106	Sink	Classroom

Clear floor space not provided at sink Toe and knee clearances not provided	- -	Reconfigure furniture to provide a 30" by 48" clear floor space positioned for a forward approach. Remove trash bins to ensure there is a 25" knee clearance positioned for a forward approach.	1	Labor	\$0
Access to Goods and Services												
15	2nd Grade Classroom	1	108	Doors, Doorways, & Gates	Classroom

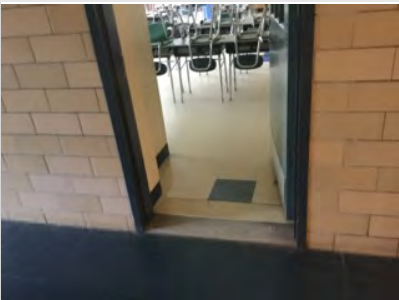
Threshold not beveled Threshold > 1/2" high	- .75"	Bevel threshold. Alter threshold to be 1/2" high max.	1	75	\$75
16	2nd Grade Classroom	1	108	Operable Parts

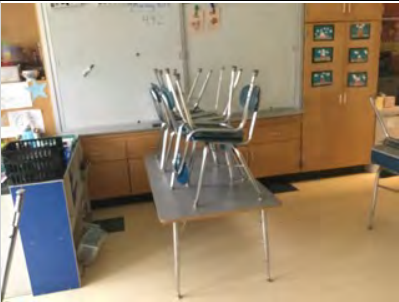
Clear floor space is not provided	-	Relocate desks so that there is a 36" wide space in front of the white board.	1	Labor	\$0
17	2nd Grade Classroom	1	108	Dining or Work Surfaces	Work Surface

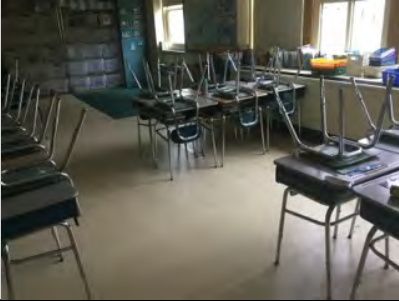
At least one or 5% accessible tables not provided	18" wide	Ensure that at least one work surface is accessible.	1	350	\$350

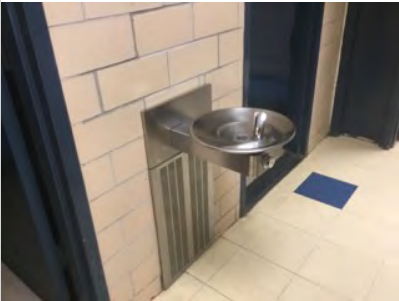
Additional Access												
18	Drinking Fountain Near Classroom 108	1	108	Drinking Fountains	Low

No drinking fountain provided for standing users	-	Provide an additional drinking fountain for standing users.	1	2014	\$2014

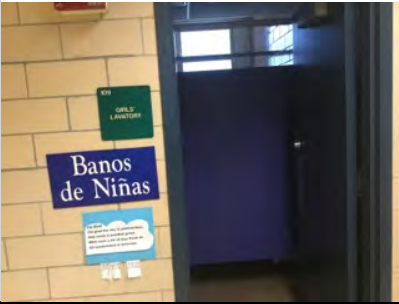
ID	Location	Floor	Room	Element	Type	Photo	Issues	Current Measure	Recommendations	Quantity	Price	Cost Estimation
Access to Goods and Services												
19	Girls' Toilet Room 109	1	109	Signage	Designation

International Symbol of Acc. not compliant	-	After the toilet room is made accessible, provide a sign containing the International Symbol of Accessibility.	1	116	\$116
Approach and Entrance												
20	Exit 4 to Crosby St.	1	110	Emergency Exit	N/A

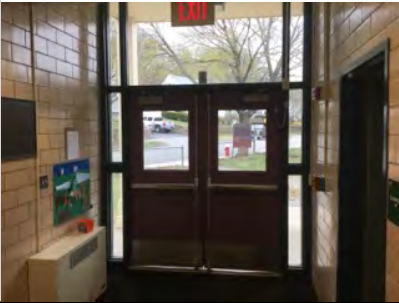
International Symbol of Acc. not provided Tactile exit sign not provided	-	Provide the International Symbol of Accessibility on the illuminated exit sign above exit doors. Provide a tactile exit signs with raised characters and braille at exit doors. Mount signs between 48" - 60" above the finished floor on the latch side of the door.	2	116	\$232
Access to Goods and Services												
21	Girls' Toilet Room 117	1	117	Signage	Designation

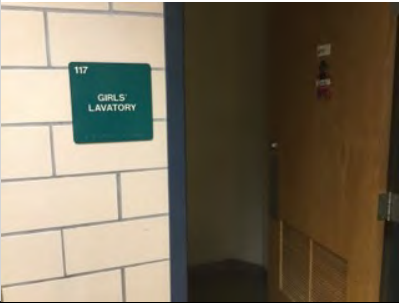
International Symbol of Acc. not compliant	-	After the toilet room is made accessible, provide a sign containing the International Symbol of Accessibility.	1	116	\$116

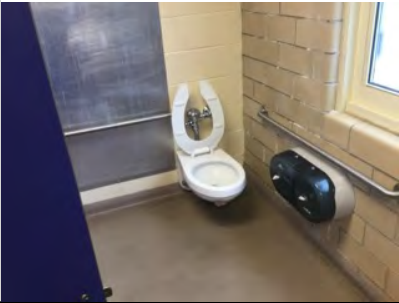
Toilet Rooms for Children												
22	Girls' Toilet Room 117	1	117	Toilet Compartment	Accessible Compartment

Door with malfunctioning self-closing hinge Centerline < 12" or > 15" (Ages 5 - 8) Non-compliant toilet paper dispenser	- 16" -	For users in Grades K-3: Repair self-closing hinge. Relocate toilet so that the centerline is between 12" and 15" from the side wall. Replace toilet paper dispenser if it does not allow continuous paper flow.	1	Labor 1767	\$1767

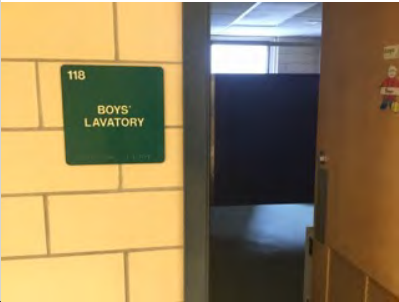
ID	Location	Floor	Room	Element	Type	Photo	Issues	Current Measure	Recommendations	Quantity	Price	Cost Estimation
Access to Goods and Services												
23	Boys' Toilet Room 118	1	118	Signage	Designation

International Symbol of Acc. not compliant	-	After the toilet room is made accessible, provide a sign containing the International Symbol of Accessibility.	1	116	\$116
Toilet Rooms for Children												
24	Boys' Toilet Room 118	1	118	Toilet Compartment	Accessible Compartment

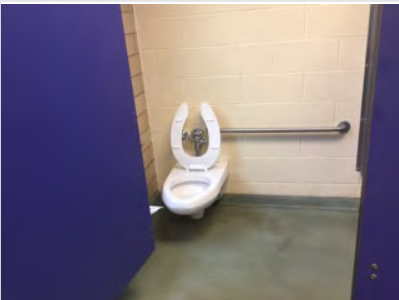
Door has incorrect swing Door with malfunctioning self-closing hinge Toilet seat < 12" or > 15" high (Ages 5 - 8) Centerline < 12" or > 15" (Ages 5 - 8) Non-compliant toilet paper dispenser	- - 16" 16" -	For users in Grades K-3: Reverse swing at door and replace keeper. Repair self-closing hinge. Install a toilet with a seat between 12"- 15" high above the finished floor. Relocate toilet so that the centerline is between 12" and 15" from the side wall. Replace toilet paper dispenser if it does not allow continuous paper flow.	1	2978 Labor	\$2978

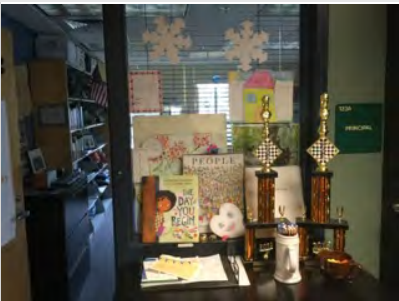
Access to Goods and Services												
25	Principal's Office	1	123a	Signage	Designation

Sign not located on the latch side of the door	-	Locate sign at permanent rooms alongside the door on the latch side.	1	Labor	\$0
Access to Goods and Services												
26	Conference Room 123b	1	123b	Signage	Designation

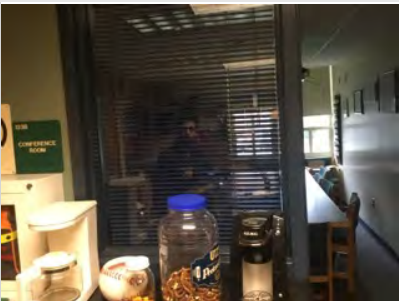
Sign not located on the latch side of the door	-	Locate sign at permanent rooms alongside the door on the latch side.	1	Labor	\$0

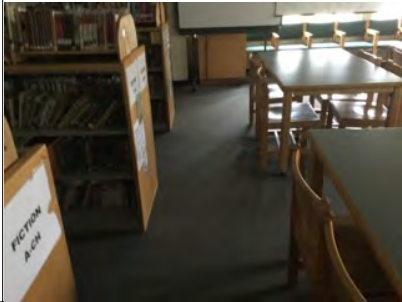
ID	Location	Floor	Room	Element	Type	Photo	Issues	Current Measure	Recommendations	Quantity	Price	Cost Estimation
Access to Goods and Services												
27	Library Media Room	1	124	Interior Access Route	N/A

Route < 36" wide	32"	Ensure that a clear width of 36" min. is maintained at the accessible route. Relocate furniture.	1	Labor	\$0
Approach and Entrance												
28	Gymnasium	1	132	Emergency Exit	N/A

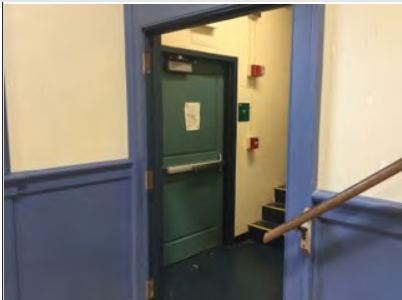
Emergency exit not on an accessible route Directional sign to accessible emergency exit not provided Tactile exit sign not provided	- -	Provide a directional sign indicating the location of the nearest emergency exit. Provide a tactile exit signs with raised characters and braille at exit doors. Mount signs between 48" - 60" above the finished floor on the latch side of the door.	2	116	\$232
Access to Goods and Services												
29	Gymnasium	1	132	Platform Lift or LULA Elevator	Interior

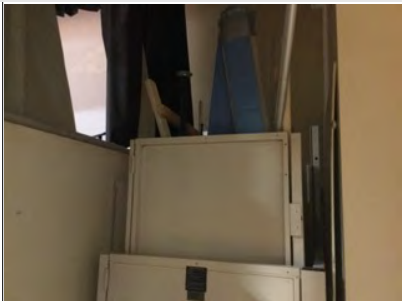
Not in operable working condition Not independently operable	- -	Ensure lift is maintained in operable working condition. Adjust controls to be independently operable.	1	Labor	\$0

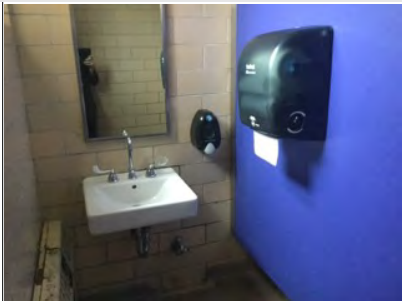
Toilet & Bathing Rooms												
30	First and Second Floor Girls' Toilet Room	1 2	109 209	Dispensers	Paper Towel Dispenser

Not operable with a closed fist Dispenser acts as a protruding object	- 10"	Provide a dispenser that can be operable with one hand and not require tight grasping, pinching, or twisting of the wrist. Relocate dispenser out of the circulation path.	2	453	\$906

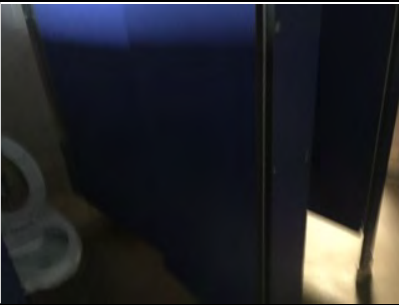
ID	Location	Floor	Room	Element	Type	Photo	Issues	Current Measure	Recommendations	Quantity	Price	Cost Estimation
31	First and Second Floor Girls' Toilet Room	1 2	109 209	Overall Access	Toilet Room

Accessible plumbing fixtures or stalls not provided	-	Provide one accessible wheelchair stall.	2	3091	\$6182
Toilet & Bathing Rooms												
32	Girls' Toilet Rooms	1 2	109 209	Lavatory	N/A

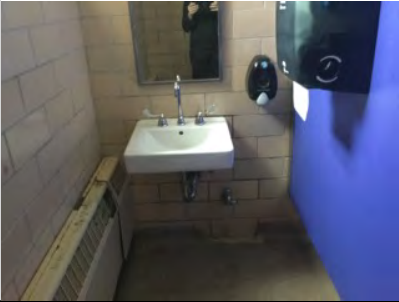
Clear floor space not provided at lavatory Plumbing underneath is exposed	- -	Provide at least one lavatory with a 30" min. by 48" min. clear floor space positioned for a forward approach. Insulate or otherwise configure pipes to prevent contact at lavatory.	2	46	\$92
Access to Goods and Services												
33	First and Second Floor Boys' Toilet Room	1 2	110 210	Signage	Designation

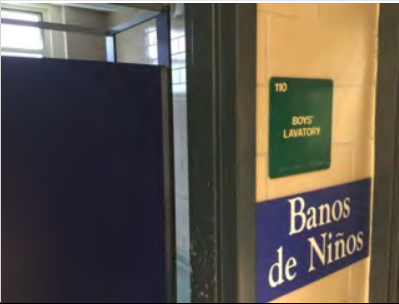
International Symbol of Acc. not compliant	-	After the toilet room is made accessible, provide a sign containing the International Symbol of Accessibility.	2	116	\$232

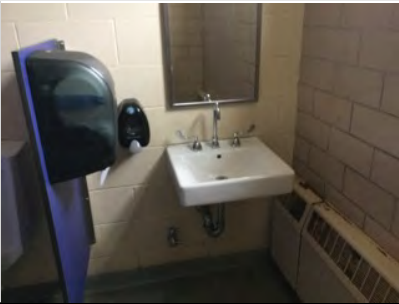
Toilet & Bathing Rooms												
34	First and Second Floor Boys' Toilet Room	1 2	110 210	Lavatory	N/A

Plumbing underneath is exposed	-	Insulate or otherwise configure pipes to prevent contact at lavatory.	2	46	\$92
35	First and Second Floor Boys' Toilet Room	1 2	110 210	Dispensers	Paper Towel Dispenser

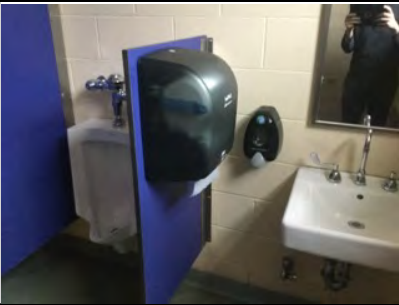
Not operable with a closed fist Dispenser acts as a protruding object	- 10"	Provide a dispenser that can be operable with one hand and not require tight grasping, pinching, or twisting of the wrist. Relocate dispenser out of the circulation path.	2	453	\$906

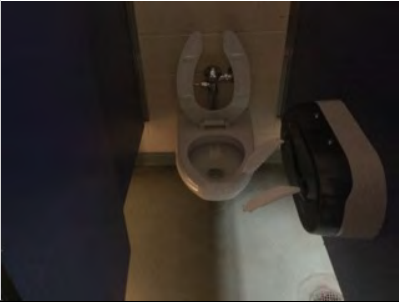
ID	Location	Floor	Room	Element	Type	Photo	Issues	Current Measure	Recommendations	Quantity	Price	Cost Estimation
36	First and Second Floor Boys' Toilet Room	1 2	110 210	Overall Access	Toilet Room

Accessible plumbing fixtures or stalls not provided	-	Provide one accessible wheelchair stall.	2	3091	\$6182
Access to Goods and Services												
37	Classroom 202	2	202	Signage	Designation

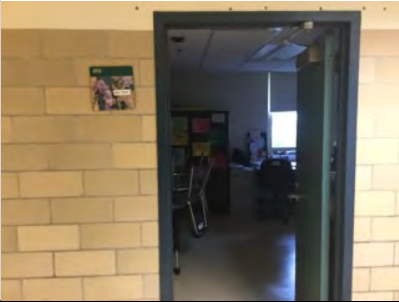
Raised characters < 48" or > 60" above ground Braille misplaced	68"	Mount signs so that the baseline of the lowest tactile character is 48" min. above finish floor and the baseline of the highest tactile character is 60" max. above finished floor. Do not block raised characters and/or braille with printed out signs. Replace signage if current designation does not correspond with old sign.	1	116	\$116
Access to Goods and Services												
38	4th Grade Classroom	2	205	Interior Access Route	N/A

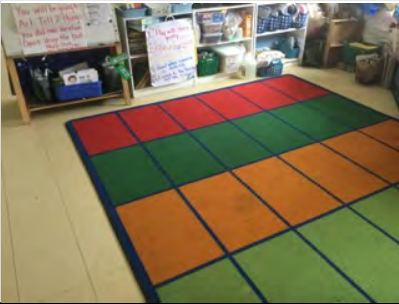
Surface not stable, firm, and slip-resistant	-	Secure the mat.	1	Labor	\$0

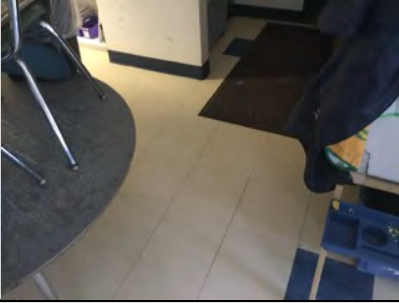
39	4th Grade Classroom	2	205	Interior Access Route	N/A

Route < 36" wide	22"	Ensure that a clear width of 36" min. is maintained at the accessible route. Relocate furniture.	1	Labor	\$0
Access to Goods and Services												
40	Classroom 205 Toilet Room	2	205	Signage	Designation

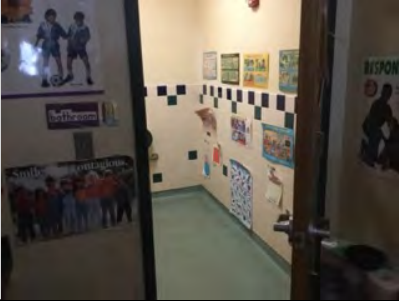
Raised characters not provided Braille not provided Non glare finish and contrast not provided	- - -	Provide text with raised characters duplicated in braille. Provide signs with a non-glare finish.	1	116	\$116

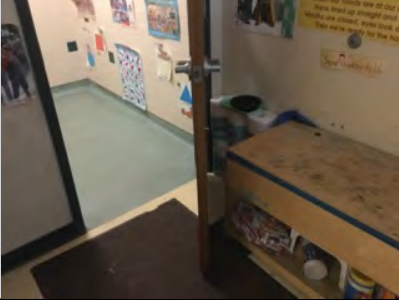
ID	Location	Floor	Room	Element	Type	Photo	Issues	Current Measure	Recommendations	Quantity	Price	Cost Estimation
41	Classroom 205 Toilet Room	2	205	Doors, Doorways, & Gates	Toilet Room

Clear width at door < 32"	-	Remove cabinet to ensure 32" min. clear width at doorways.	1	Labor	\$0
Toilet Rooms for Children												
42	Classroom 205 Toilet Room	2	205	Single-User Toilet	N/A

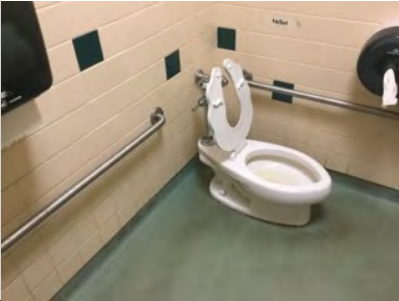
Side or rear grab bar < 20" or > 25" high (K - 3) Non-compliant toilet paper dispenser	19" -	Locate grab bar between 20"- 25" above the floor. Relocate toilet paper dispenser so that it is between 14"- 17" above the floor and between 7"- 9" in front of the toilet. Ensure dispensers and other devices are not mounted above grab bars. Replace toilet paper dispenser if it does not allow continuous paper flow.	1	1059	\$1059
Additional Access												
43	Classroom 205 Toilet Room	2	205	Sinks for Children's Use	Sink

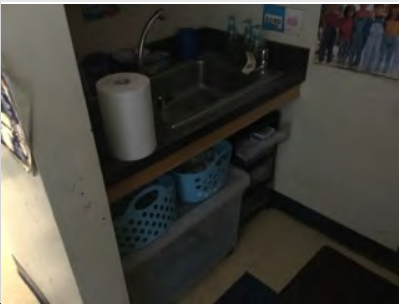
Knee or toe clearance not provided		Provide at least one sink with 25" knee and toe clearance positioned for a forward approach. Relocate stored items.	1	Labor	\$0

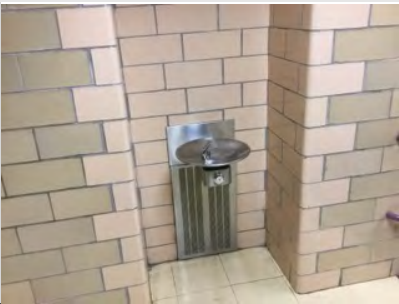
Additional Access												
44	Drinking Classroom Near 208	2	208	Drinking Fountains	Low

No drinking fountain provided for standing users	-	Install a Hi-Lo drinking fountain.	1	2108	\$2108

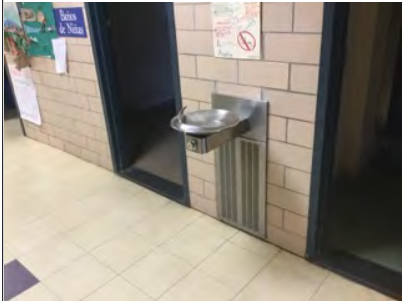
ID	Location	Floor	Room	Element	Type	Photo	Issues	Current Measure	Recommendations	Quantity	Price	Cost Estimation
Additional Access												
45	Drinking Fountain Near Classroom 208	2	208	Drinking Fountains	Low

No drinking fountain provided for standing users	-	Provide an additional drinking fountain for standing users.	1	2014	\$2014
Access to Goods and Services												
46	Classroom 211	2	211	Dining or Work Surfaces	Work Surface

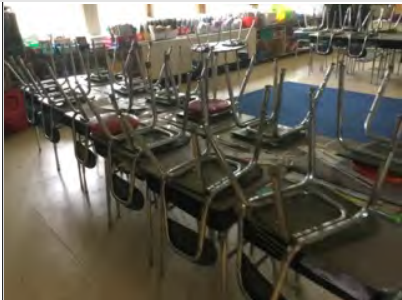
At least one or 5% accessible tables not provided	19" wide	Ensure that at least two desks are accessible.	2	350	\$700
47	Classroom 211	2	211	Interior Access Route	N/A

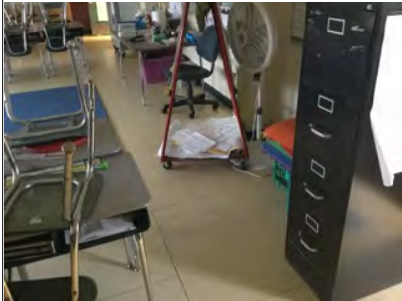
Route < 36" wide	20"	Relocate desks to ensure that a clear width of 36" min. is maintained at the accessible route. Relocate furniture.	1	Labor	\$0
48	Classroom 211	2	211	Interior Access Route	N/A

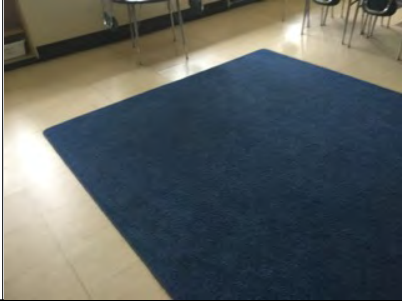
Surface not stable, firm, and slip-resistant	-	Secure the mat.	1	Labor	\$0
49	Classroom 211	2	211	Operable Parts	Equipment

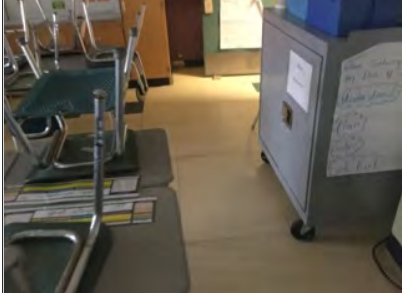
Clear floor space is not provided	-	Reconfigure desk layout to provide a 30" min. by 48" min. clear floor space at laptop trolley.	1	Labor	\$0

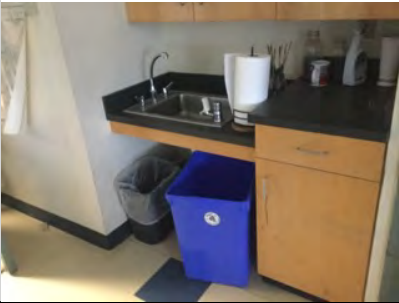
ID	Location	Floor	Room	Element	Type	Photo	Issues	Current Measure	Recommendations	Quantity	Price	Cost Estimation
Additional Access												
50	Classroom 211	2	211	Sink	Classroom

Toe and knee clearances not provided	-	Remove trash bins so that there is a 25" knee clearance positioned for a forward approach.	1	Labor	\$0
Access to Goods and Services												
51	3rd Grade Classroom	2	212	Signage	Designation

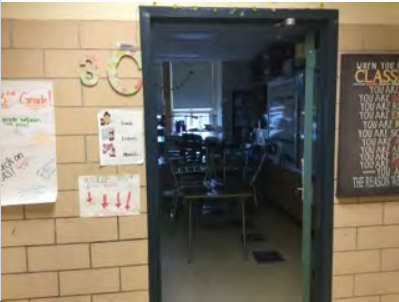
Not provided		Locate designation signage with raised characters and braille alongside the door on the latch side.	1	116	\$116
52	3rd Grade Classroom	2	212	Interior Access Route	N/A

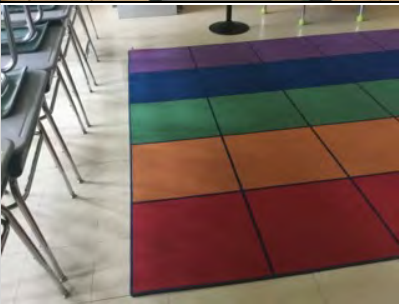
Surface not stable, firm, and slip-resistant	-	Secure the mat.	1	Labor	\$0
Access to Goods and Services												
53	3rd Grade Classroom	2	213b	Interior Access Route	N/A

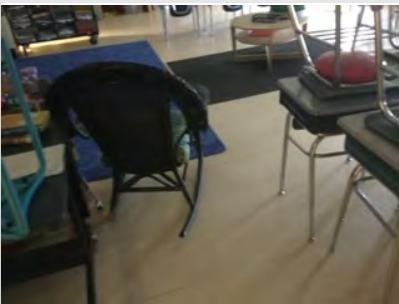
Route < 36" wide	-	Ensure that a clear width of 36" min. is maintained at the accessible route. Relocate furniture.	1	Labor	\$0

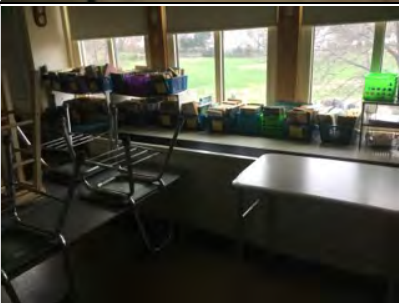
54	3rd Grade Classroom	2	213b	Operable Parts	Cubbies

Element not on an accessible route Clear floor space is not provided	- -	Reconfigure desks to ensure student cubbies are located on an accessible route. Provide a 30" min. by 48" min. clear floor space at the cubbie counter.	1	Labor	\$0

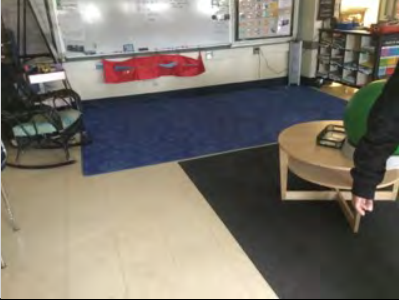
ID	Location	Floor	Room	Element	Type	Photo	Issues	Current Measure	Recommendations	Quantity	Price	Cost Estimation
55	3rd Grade Classroom	2	213b	Interior Access Route	N/A

Surface not stable, firm, and slip-resistant	-	Secure the mat.	2	Labor	\$0
Additional Access												
56	3rd Grade Classroom	2	213b	Sink	Classroom

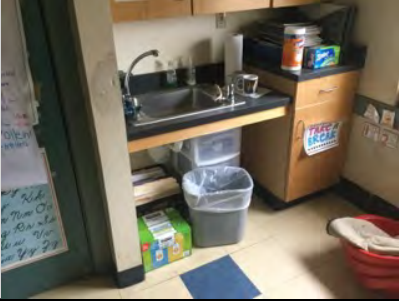
Toe and knee clearances not provided	-	Remove trash bins to ensure there is a 25" knee clearance positioned for a forward approach.	1	Labor	\$0
Toilet & Bathing Rooms												
57	Girls' Toilet Room 217	2	217	Overall Access	Toilet Room

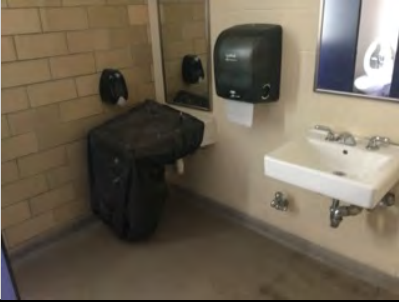
Accessible plumbing fixtures or stalls not provided	-	Repair broken accessible lavatory.	1	Labor	\$0
Toilet Rooms for Children												
58	Girls' Toilet Room 217	2	217	Toilet Compartment	Accessible Compartment

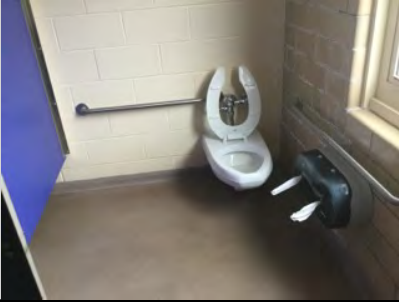
Non-compliant toilet paper dispenser	-	Replace dispenser if it does not allow continuous paper flow.	1	353	\$353

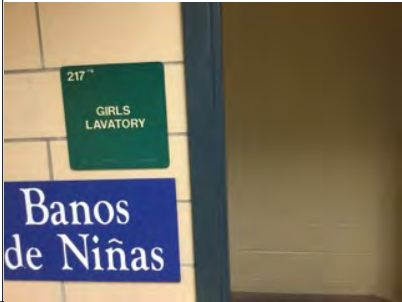
ID	Location	Floor	Room	Element	Type	Photo	Issues	Current Measure	Recommendations	Quantity	Price	Cost Estimation
Access to Goods and Services												
59	Second Floor Girls' Toilet Room	2	217	Signage	Designation

International Symbol of Acc. not compliant	-	After the toilet room is made accessible, provide a sign containing the International Symbol of Accessibility.	1	116	\$116
Access to Goods and Services												
60	Boys' Toilet Room 218	2	218	Signage	Designation

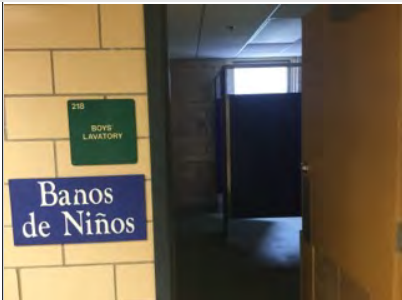
International Symbol of Acc. not compliant	-	After the toilet room is made accessible, provide a sign containing the International Symbol of Accessibility.	1	116	\$116
Toilet Rooms for Children												
61	Boys' Toilet Room 218	2	218	Toilet Compartment	Accessible Compartment

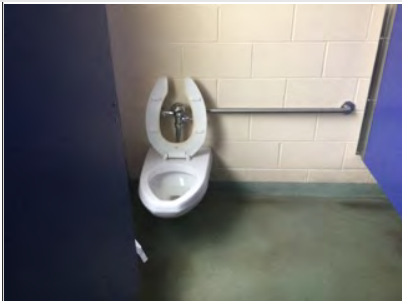
Door has incorrect swing Door with malfunctioning self-closing hinge Side or rear grab bar < 25" or > 27" high (Ages 9 - 12) Non-compliant toilet paper dispenser	- - 24" -	For users in Grades 3-5: Reverse swing at door and replace keeper. Repair self-closing hinge. Relocate grab bars to 25"- 27" above the floor. Replace toilet paper dispenser if it does not allow continuous paper flow.	1	1187 Labor	\$1187

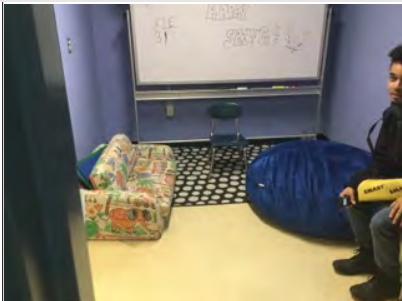
Best Practice												
62	One-on-One Work Room	2	222		Seating

Best Practice: Consider providing a variety of seating options with and without arms, backs, and at various heights.	1	-	\$0

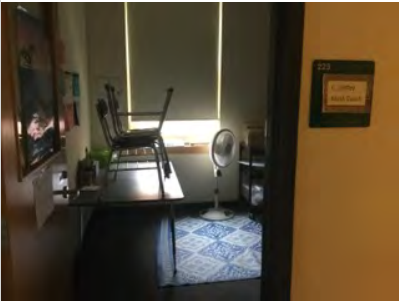
ID	Location	Floor	Room	Element	Type	Photo	Issues	Current Measure	Recommendations	Quantity	Price	Cost Estimation
Access to Goods and Services												
63	Speech Coach Office	2	223	Signage	Designation

Braille misplaced		Do not block raised characters and/or braille with printed out signs. Replace signage if current designation does not correspond with old sign.	1	116	\$116
64	Speech Coach Office	2	223	Interior Access Route	N/A

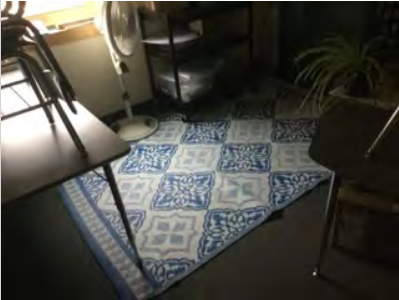
Route < 36" wide Surface not stable, firm, and slip-resistant	26" -	Ensure that a clear width of 36" min. is maintained at the accessible route. Relocate furniture. Secure the mat.	1	Labor	\$0
Access to Goods and Services												
65	Learning Center	2	225	Dining or Work Surfaces	Work Surface

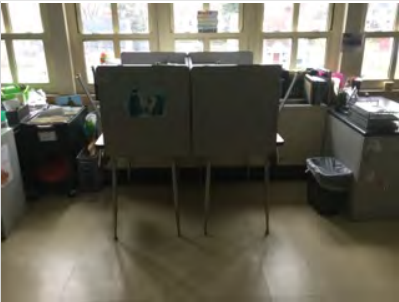
At least one or 5% accessible tables not provided	24" wide	Ensure that at least one testing desk is accessible.	1	350	\$350
Access to Goods and Services

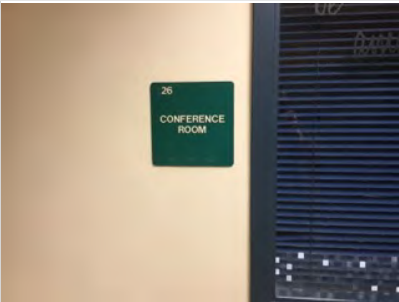
66	Conference Room 226	2	226	Signage	Designation

Raised characters not provided	-	Replace sign, as current sign has broken raised characters.	1	116	\$116
67	Conference Room 226	2	226	Operable Parts	Switch

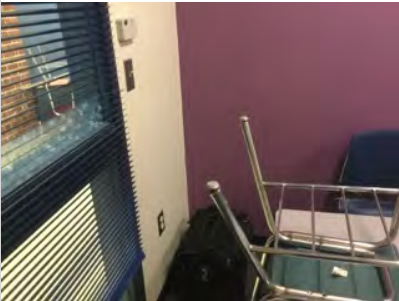
Element not on an accessible route Clear floor space is not provided	- -	Reconfigure furniture layout to ensure light switch located on an accessible route. Provide a 30" min. by 48" min. clear floor space at the light switch.	1	Labor	\$0

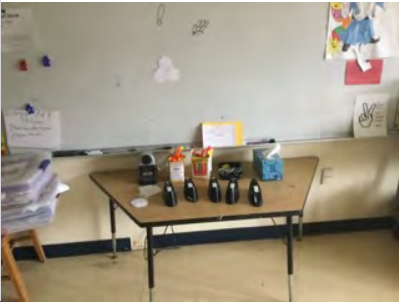
Clear floor space is not provided	-	Reconfigure desks so that there is 36" min. clear width at the white board.	1	Labor	\$0
Additional Access												
69	Computer/ Art Room	2	227	Sink	Classroom

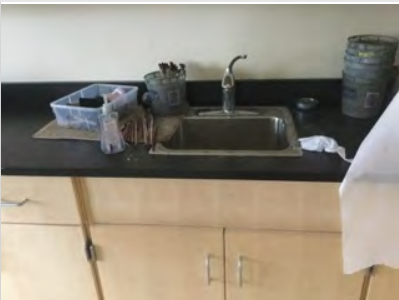
Toe and knee clearances not provided	-	Remove cabinet and provide bracing to ensure that there is a 25" knee clearance positioned for a forward approach.	1	843	\$843
Best Practice												
70	Computer/ Art Room	2	227		Signage

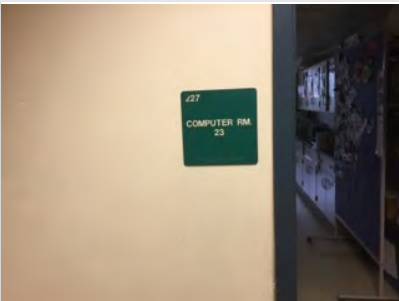
Best Practice: This sign does not reflect the program observed by IHCD staff at the time of review. If this room is to permanently change programs, update signage to reflect the current designation.	1	-	\$0
Best Practice												
71	Science/ Music Room	2	228		Signage

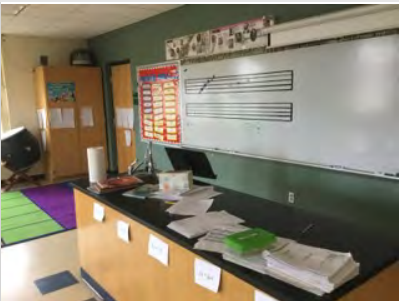
Best Practice: The sign for this room does not reflect the program observed by IHCD staff at the time of review. If this room is to permanently change programs, update signage to reflect the current designation.	1	-	\$0

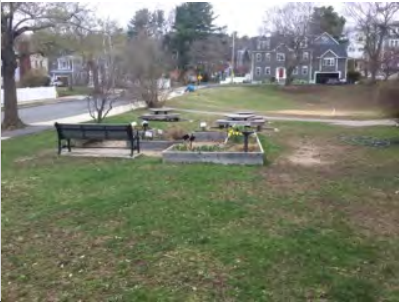
Accessible route not provided	-	Ensure an accessible route is provided. (Cost estimate based on the installation of 20 ft. of stone dust path.)	1	456	\$456
73	Garden Near Main Entrance	Ext.		Exterior Access Route	Exterior

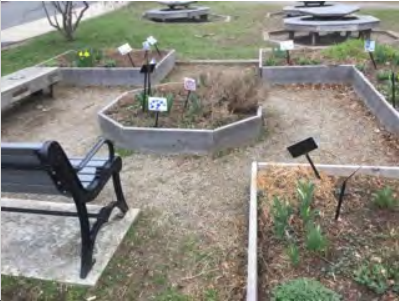
Exterior route < 36" wide Surface is not stable, firm, and slip-resistant	29" -	Redesign this garden to be 48" wide and maintained with stone dust paths. (Cost estimate for 300 sq. ft. of stone dust.)	1	2278	\$2278
Approach and Entrance												
74	Garden Near West Playground	Ext.		Exterior Access Route	Exterior

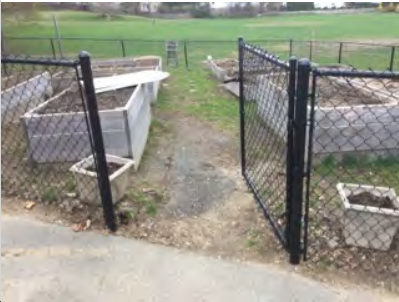
Surface is not stable, firm, and slip-resistant	-	Provide a surface that is stable, firm, and slip resistant. (Cost estimate based on the installation of 200 sq. ft. of stone dust.)	1	1518	\$1518

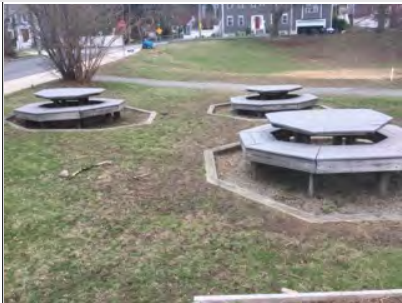
At least 5% accessible spaces not provided Picnic table not on an accessible route	- -	Ensure that at least 5% (minimum one) of dining surfaces are accessible. Ensure that the dining surface is connected to an accessible route. (Cost estimate based on an accessible picnic table and a 10' long stone dust path.)	1	1628	\$1628

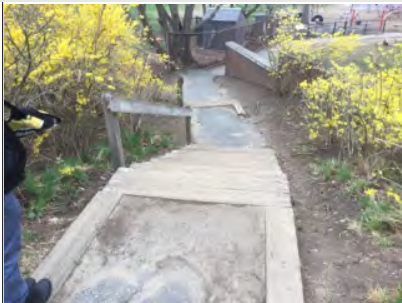
Best Practice												
78	Route From Crosby St. to West Playground	Ext.			Stairs

-	Best Practice: IHCD recommends redesigning stairs to be safer and easier to use; with handrails on both sides, a stable tread surface, and risers that are not more than 7 inches high.	1	-	\$0
79	Route From Crosby St. to West Playground	Ext.			Access Routes

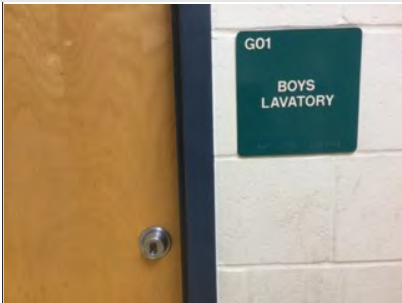
International Symbol of Acc. not compliant	-	After the toilet room is made accessible, provide a sign containing the International Symbol of Accessibility.	1	116	\$116
Toilet Rooms for Children												
82	Boys' and Girls' Toilet Room Near Cafeteria	G	G01	Paper Towel Dispenser	N/A

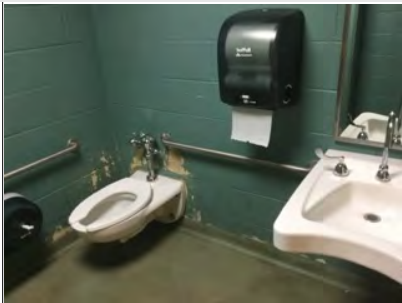
Dispenser located above grab bar	-	Relocate the paper towel dispenser so that it is not mounted above the grab bar and obstruct its use.	2	353	\$706

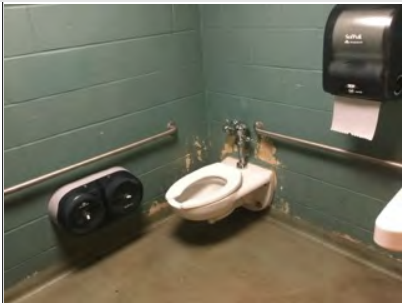
Toilet & Bathing Rooms												
83	Boys' Toilet Room Near Cafeteria	G	G01	Single-User Toilet	N/A

Toilet paper dispenser is not compliant	-	Replace toilet paper dispenser if it does not allow continuous paper flow.	1	353	\$353

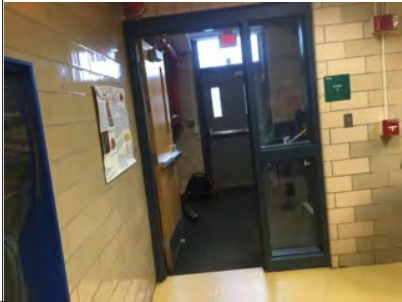
International Symbol of Acc. not provided Tactile exit sign not provided	-	Provide the International Symbol of Accessibility on the illuminated exit sign above exit doors. Ensure tactile exit signs with raised characters and braille are provided at exit doors. Mount signs between 48" - 60" above the finished floor on the latch side of the door.	2	116	\$232
Access to Goods and Services												
85	Girls' Single-User Toilet Room Near Cafeteria	G	G02	Signage	Designation

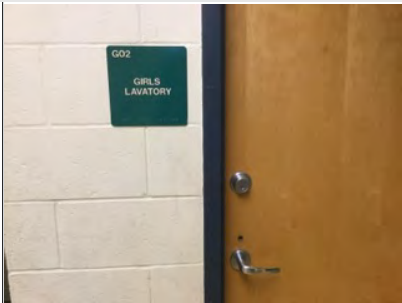
International Symbol of Acc. not compliant	-	After the toilet room is made accessible, provide a sign containing the International Symbol of Accessibility.	1	116	\$116
Toilet & Bathing Rooms

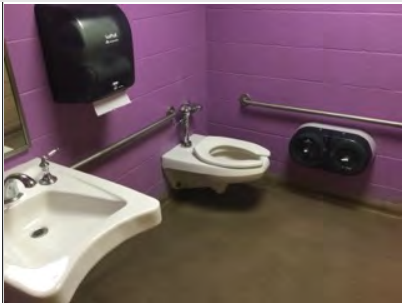
86	Girls' Single-User Toilet Room Near Cafeteria	G	G02	Single-User Toilet	N/A

Toilet paper dispenser is not compliant	-	Replace toilet paper dispenser if it does not allow continuous paper flow.	1	353	\$353
Approach and Entrance												
87	OT/PT Room	G	G07a	Emergency Exit	N/A

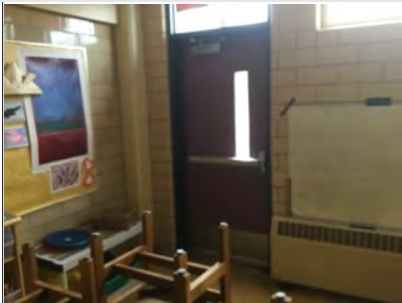
International Symbol of Acc. not provided Tactile exit sign not provided	-	Provide the International Symbol of Accessibility on the illuminated exit sign above exit doors. Ensure tactile exit signs with raised characters and braille are provided at exit doors. Mount signs between 48" - 60" above the finish floor on the latch side of the door.	2	116	\$232

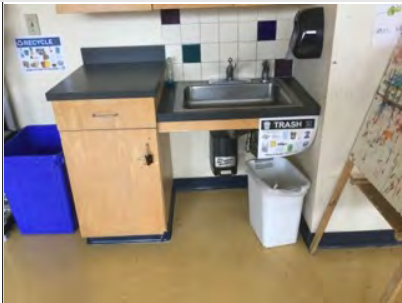
Toe and knee clearances not provided Exposed plumbing underneath sink	- -	Remove trash bin and garbage disposal to ensure there is a 27" knee clearance positioned for a forward approach. Insulate or otherwise configure pipes at sink.	1	46	\$46
Approach and Entrance												
90	Cafeteria	G	G08	Emergency Exit	N/A

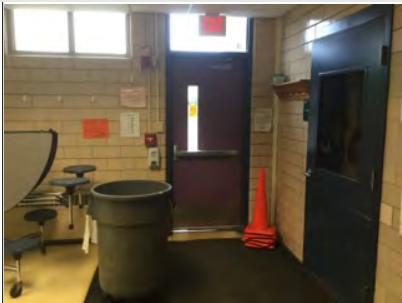
International Symbol of Acc. not provided Tactile exit sign not provided	-	Provide the International Symbol of Accessibility on the illuminated exit sign above exit doors. Ensure tactile exit signs with raised characters and braille are provided at exit doors. Mount signs between 48" - 60" above the finished floor on the latch side of the door.	2	116	\$232

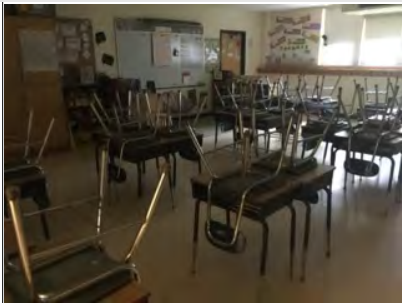
Access to Goods and Services												
91	5th Grade Classroom	G	G11	Dining or Work Surfaces	Work Surface

At least one or 5% accessible tables not provided	18" wide	Ensure that at least one desk is accessible.	1	350	\$350

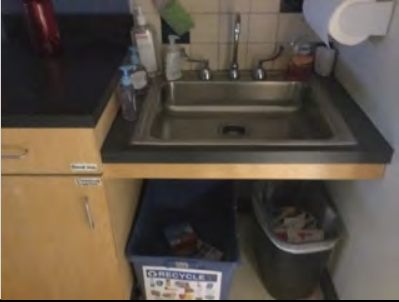
Toe and knee clearances not provided	-	Remove trash bins so that there is a 25" knee clearance positioned for a forward approach.	1	Labor	\$0

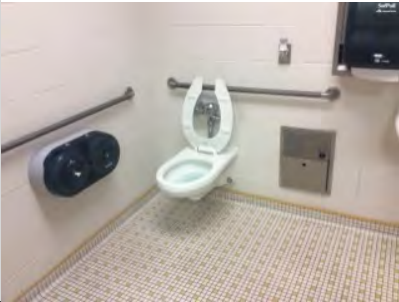
Centerline < or > 18" (MAAB) Toilet paper dispenser is not compliant	19" -	Relocate toilet so that the centerline is 18" from the side wall. Replace toilet paper dispenser with one that allows continuous paper flow.	1	1767	\$1767
2	All-Gender Toilet Room in 5th Grade Classroom	1		Dispensers	Paper Towel Dispenser

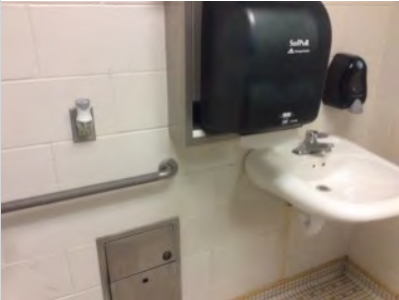
Dispenser is a protruding object	-	Relocate dispenser out of the circulation path and/or provide a low-profile dispenser.	1	353	\$353
Toilet & Bathing Rooms												
3	Boys' Toilet Room Near Cafeteria	1		Urinal	N/A

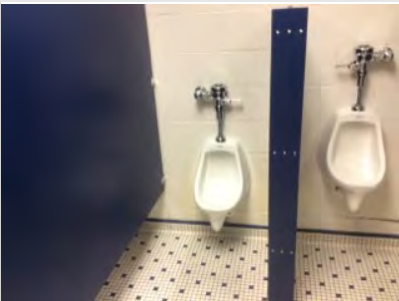
Rim > 15" high (MAAB)	16"	Provide at least one urinal with the rim no higher than 15" above the finished floor.	1	1624	\$1624
Toilet Rooms for Children

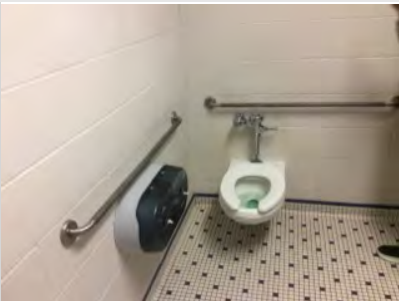
4	Boys' Toilet Room Near Cafeteria	1		Toilet Compartment	Accessible Compartment

Side or rear grab bar < 42" long Side or rear grab bar < 25" or > 27" high (Ages 9 - 12) Non-compliant toilet paper dispenser	36" 30" -	Provide a side wall grab bar that is 42" long located 6" max. from the interior corner. Relocate both grab bars to 25"- 27" above the finished floor. Replace toilet paper dispenser with one that allows continuous paper flow.	1	1508	\$1508

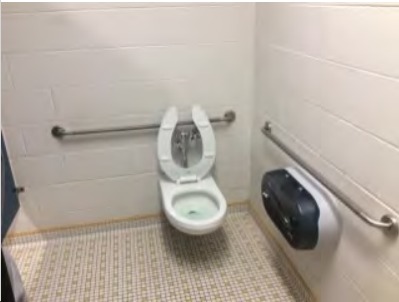
Side or rear grab bar < 42" long Side or rear grab bar < 25" or > 27" high (Ages 9 - 12) Centerline < 15" or > 18" (Ages 9 - 12) Non-compliant toilet paper dispenser	36" 30" 19" -	Provide a side wall grab bar that is 42" long located 6" max. from the interior corner. Relocate grab bars to 25"- 27" above the floor. Relocate toilet so that the centerline is between 15" and 18" from the side wall. Replace toilet paper dispenser with one that allows continuous paper flow.	1	2922	\$2922
Best Practice												
6	Main Entrance	1

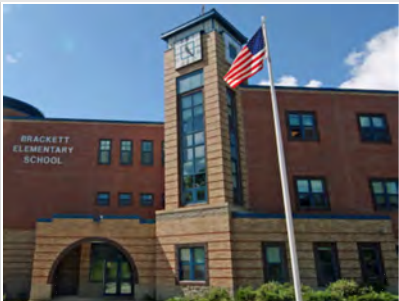
Provide an automatic door opener at the main entrance as people who cannot use their arms may need to get in the building. Provide a door bell as a back up for times when the automatic door opener is out of service. * (Priority of the Disability Commission)	1	1830	\$1830

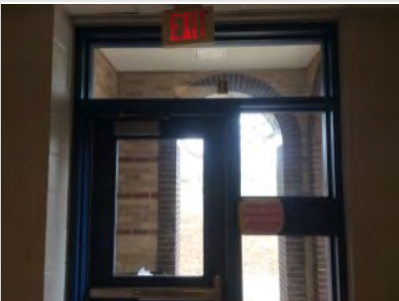
Approach and Entrance												
7	Staff Emergency Exit	1		Emergency Exit	N/A

International Symbol of Acc. not provided Tactile exit sign not provided	- -	Provide an illuminated sign with the International Symbol of Accessibility. Provide a tactile exit sign with raised characters and braille are provided at exit doors. Mount signs between 48" - 60" above the finished floor on the latch side of the door.	1	232	\$232
Approach and Entrance												
8	Stair 3 Exit	1		Emergency Exit	N/A

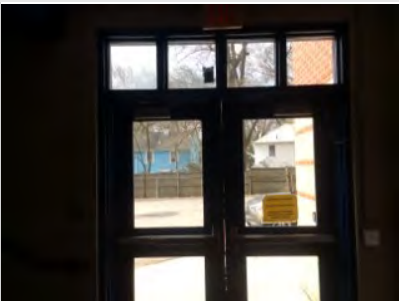
International Symbol of Acc. not provided Tactile exit sign not provided	- -	Provide an illuminated sign with the International Symbol of Accessibility. Provide a tactile exit sign with raised characters and braille are provided at exit doors. Mount signs between 48" - 60" above the finished floor on the latch side of the door.	1	232	\$232

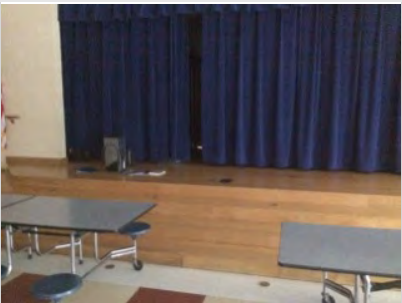
Best Practice: Recommend providing signage in the cafeteria that directs users to the accessible stage entrance at the rear of the stage.	1	-	\$0
Approach and Entrance												
11	Exit Near Stair 2	1	103	Emergency Exit	N/A

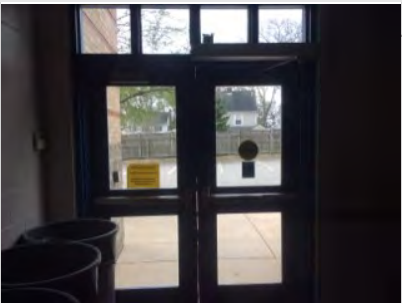
International Symbol of Acc. not provided Tactile exit sign not provided	-	Provide an illuminated sign with the International Symbol of Accessibility. Provide a tactile exit sign with raised characters and braille are provided at exit doors. Mount signs between 48" - 60" above the finished floor on the latch side of the door.	1	232	\$232

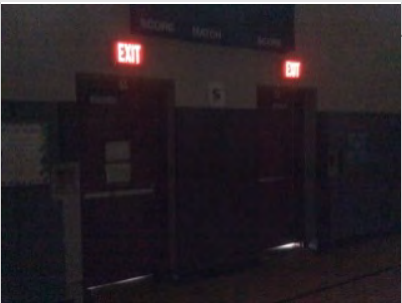
Approach and Entrance												
12	Sammarco Gymnasium	1	105	Emergency Exit	N/A

Directional sign to accessible emergency exit not provided Tactile exit sign not provided	-	Provide a directional sign indicating the location of the nearest emergency exit. Provide a tactile exit sign with raised characters and braille are provided at exit doors. Mount signs between 48" - 60" above the finished floor on the latch side of the door.	2	116	\$232

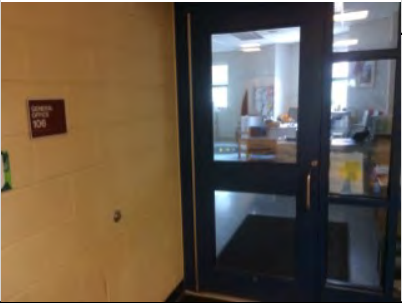
Sign not located on the latch side of the door	-	Locate sign at permanent rooms alongside the door on the latch side.	1	Labor	\$0
Access to Goods and Services												
15	Conference Room	1	106B	Operable Parts	Other

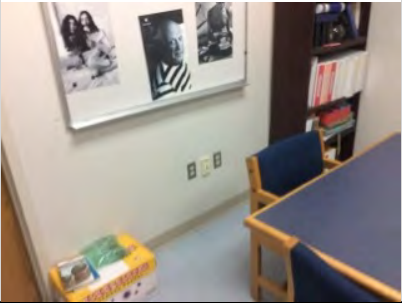
Clear floor space is not provided	-	Reconfigure room layout to provide a 30" min. by 48" min. clear floor space at the white board.	1	Labor	\$0

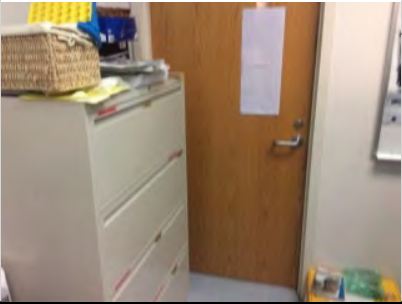
16	Conference Room	1	106B	Doors, Doorways, & Gates	Circulation

Maneuvering clearance(s) not provided		Relocate the file cabinet if this door is in use.	1	Labor	\$0

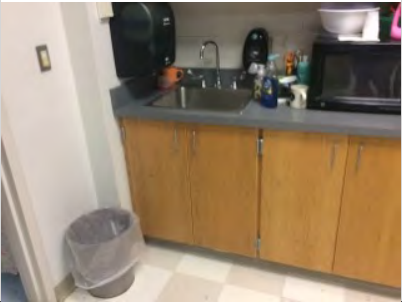
Toe and knee clearances not provided	-	If used by the public, ensure there is a 27" knee clearance positioned for a forward approach.	1	843	\$843
Best Practice												
18	Exam Room/ Nurse's Office	1	106D		Signage

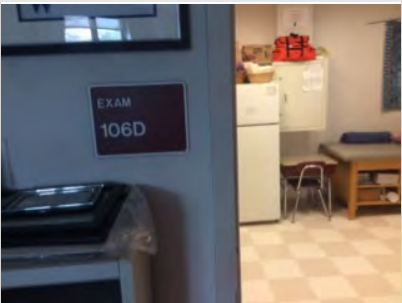
Best Practice: Sign text and braille do not match the program of the room observed by IHCD staff. If this room is to permanently become the nurse's office, provide a new sign.	1	-	\$0
Toilet & Bathing Rooms												
19	Exam Room/ Nurse's Office Toilet	1	106D	Lavatory	N/A

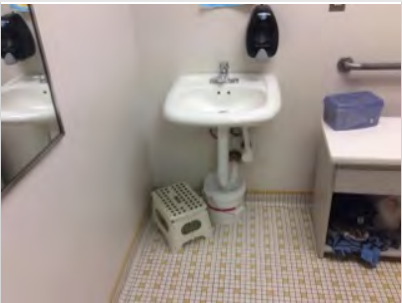
Toe or knee clearances not provided	-	Remove items at the base of the lavatory to provide toe and knee clearance.	1	Labor	\$0
20	Exam Room/ Nurse's Office Toilet	1	106D	Single-User Toilet	N/A

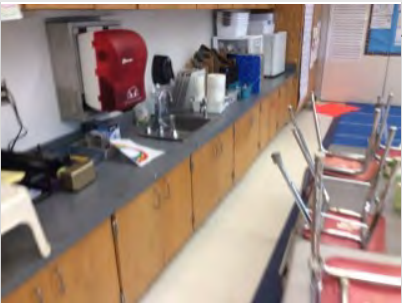
Knee or toe clearance not provided	-	Provide at least one sink with 25" knee and toe clearance positioned for a forward approach.	1	843	\$843
Access to Goods and Services												
23	All-Gender Toilet Room in 5th Grade Classroom	1	111	Signage	Designation

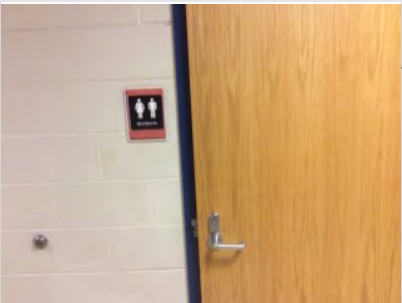
Raised characters not provided Braille not provided International Symbol of Acc. not compliant	<ul style="list-style-type: none">---	After toilet room is made accessible, replace paper sign with a sign containing the International Symbol of Accessibility, as well as raised characters duplicated in braille.	1	116	\$116

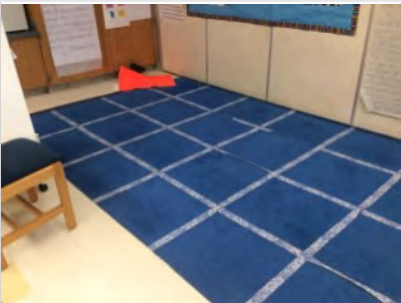
Access to Goods and Services												
24	5th Grade Classroom, Kindergarten 119	1	111 119	Interior Access Route	N/A

Surface not stable, firm, and slip-resistant	-	Secure the mats.	3	Labor	\$0

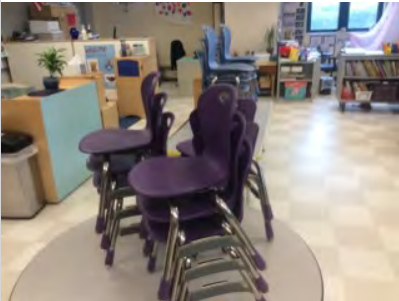
At least one or 5% accessible tables not provided	-	Provide at least one (1) accessible table with 24" min. knee clearance and 30" min. clear width. Ensure accessible work surfaces are well integrated with class seating plans.	1	350	\$350
26	1st Grade Classroom/ Resource Room	1	117	Interior Access Route	N/A
